The Early Cold War Architectural Legacy
at Holloman Air Force Base, New Mexico (ca. 1950-1960)

Holloman Air Force Base
Cultural Resources Publication No. 3

Cultural Resources Publication No. 3

December 1996

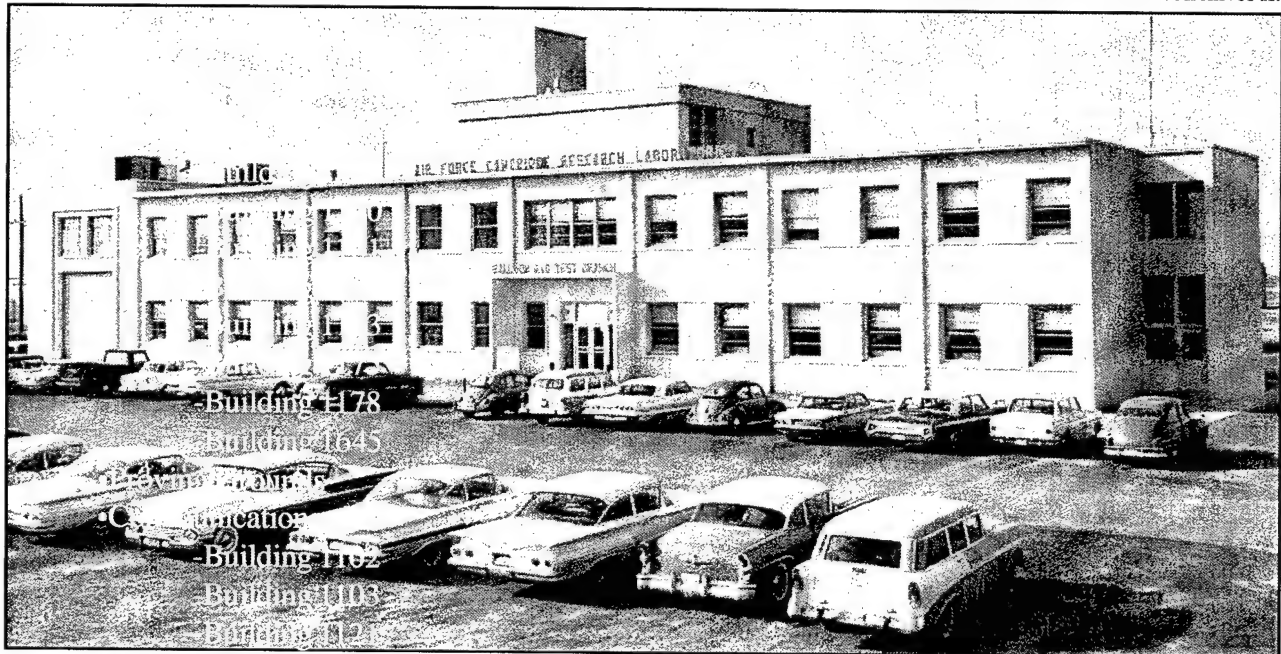
The photograph below was taken of the "Balloon Research and Development Test Branch, Air Force Cambridge Research Laboratories" now known as Building 850 (28 May 1963).

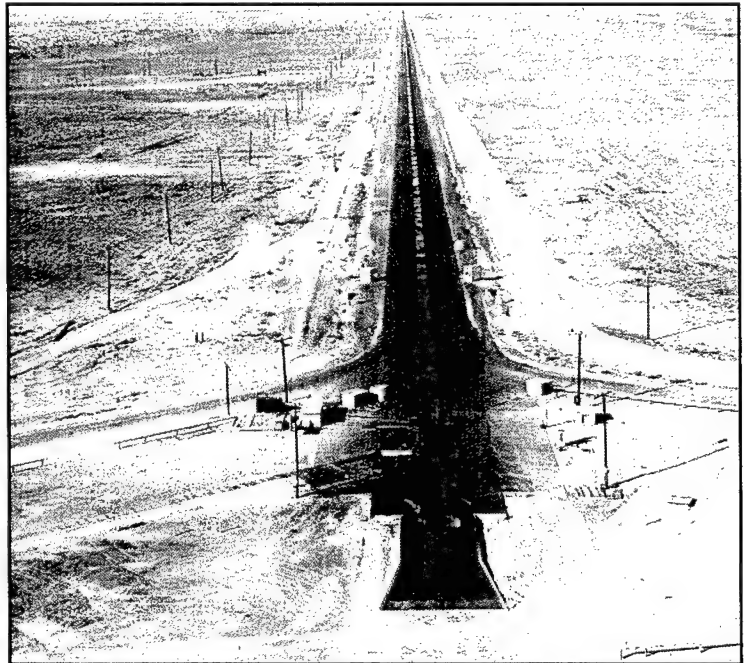
Test Track facing north, May 1963. RG 342-B. Volume II. 06-042. Archives II.

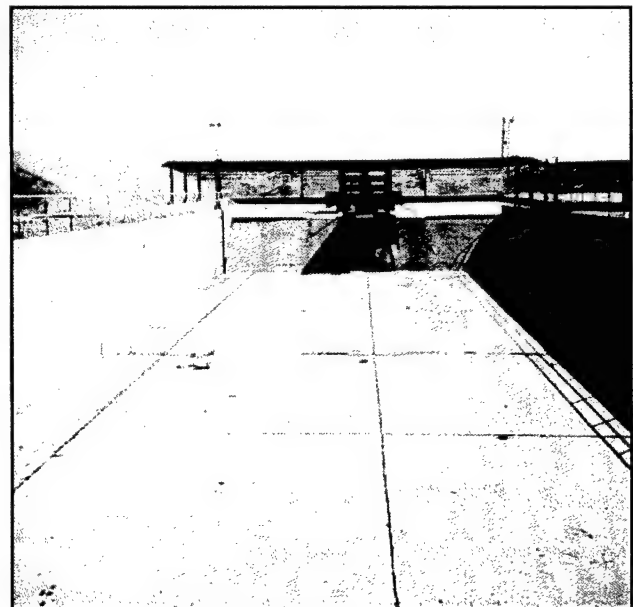
Facing south. Winter 1997.

Buildings 1159, 1160 and the concrete Test Stand itself (pictured above) comprise Holloman's unique Horizontal Test Stand Facility.

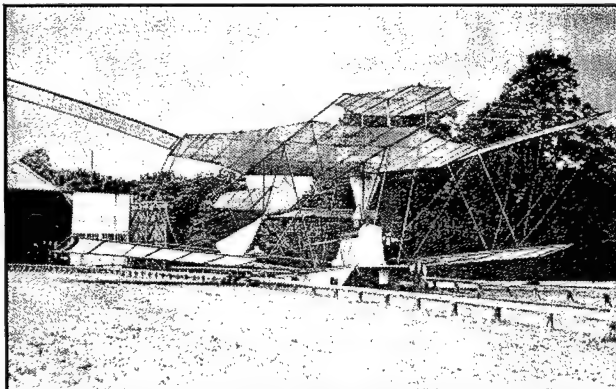
Photograph showing Hiram Maxim's airplane test track c1894. (*Istracon* 1961: 2.1).

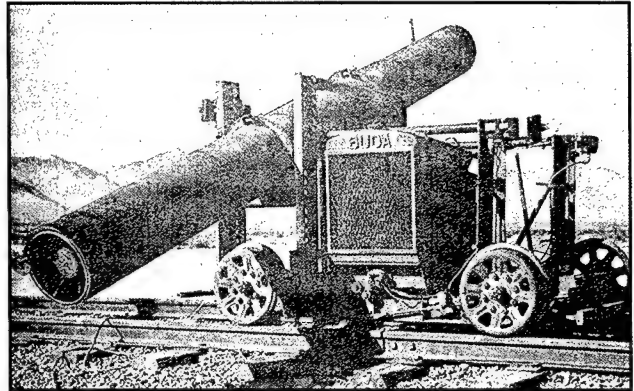
"Early track vehicle using a gasoline-powered railroad car" (*Istracon* 1961: 2.2).

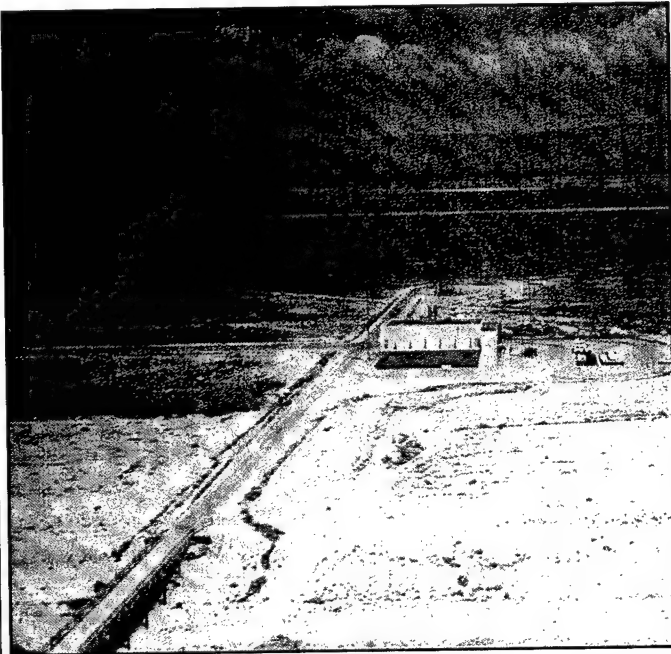
HAFB played an important role as a development and testing facility for missile and rocket research during the early Cold War. The identification and documentation of many of the buildings and structures used during this time period has provided valuable insight on a variety of Cold War construction techniques, as well as initiating steps to document, protect, and preserve this legacy of the USAF. This is extremely important since of the original early Cold War-era facilities that still exist, few retain historic integrity. The final project report can also be used to promote this demonstration project so that the forms and field methods can be used successfully on other DoD installations.

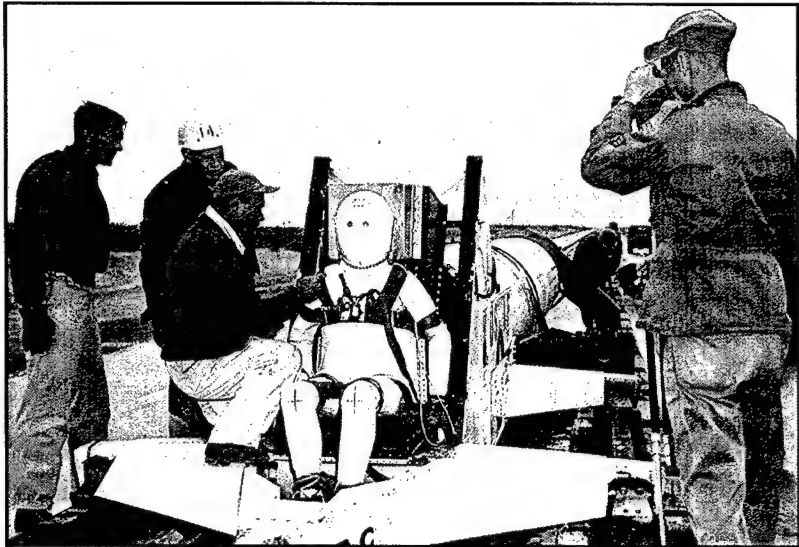
RG 342, Vol. I, 04-167, Archives II.

"Air Force Missile Development Center, NM: Workmen examine this dummy shortly after the rocket sled he was riding was stopped from a speed of 1,200 miles per hour by means of a water brake. The dummy was wearing a new windblast protection suit and helmet and the experiment, conducted by the Aeromedical Field Laboratory here, was made to see how both developmental models stood up under actual conditions. A solid propellant booster, commonly known as the "Megaboom," built by Astrodyne, Inc. of McGregor, TX was used to propel the sled and the dummy to a speed almost twice that of sound in the recent test on the 35-thousand foot captive missile test track located here." USAF Photo 1958.

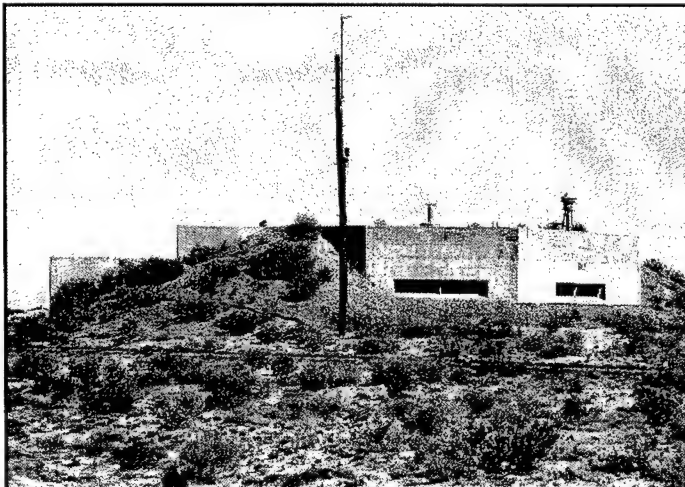
Current Condition: ☐ Intact ☒ Needs maintenance ☐ Deteriorated ☐ Archaeological

Foundation: **Concrete footing and slab.**

Suggested routine maintenance: Repair, prime, and paint spalling concrete at exterior.

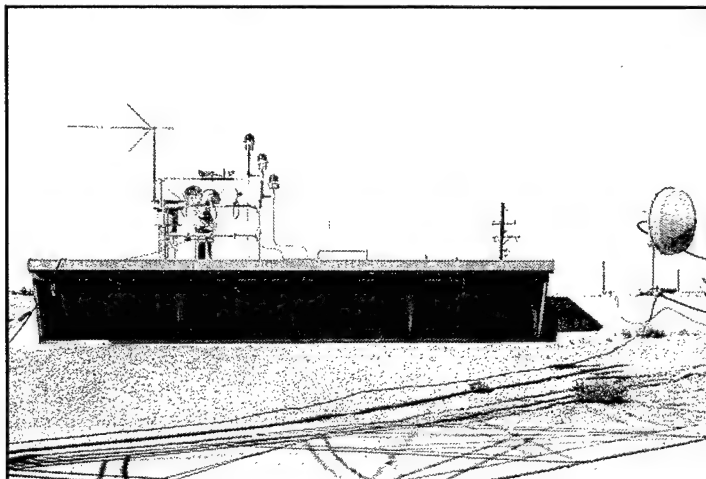
Current Condition: ☐ Intact ☒ Needs maintenance ☐ Deteriorated ☐ Archaeological

Foundation: **Concrete footings.**

Building 1175 retains historic integrity. Due to its national level of significance under Criteria A and C, recommend that Building 1175 be listed along with the other test track support buildings as part of a Multiple Property nomination to the National Register of Historic Places.

Suggested routine maintenance: Repair bond beam where steel is exposed. Remove vegetation at exterior embankments. Remove debris at front walkway.

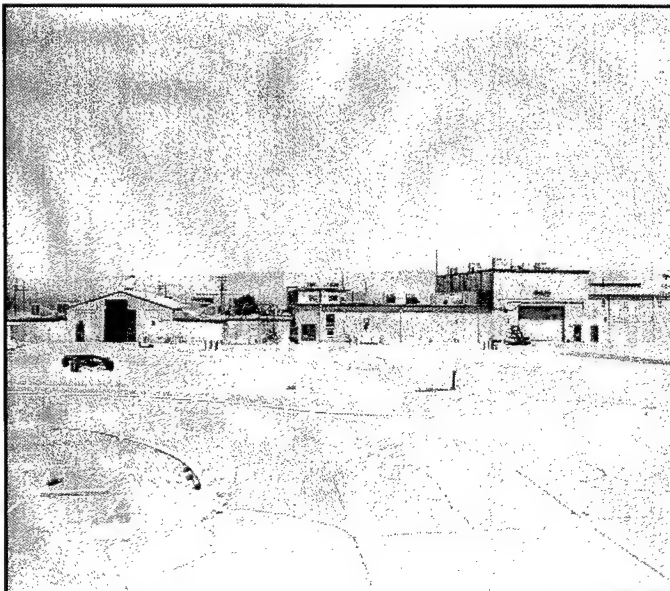
Current Condition: ☒ Intact ☐ Needs maintenance ☐ Deteriorated ☐ Archaeological

Foundation: Concrete wall and column footings. Reinforced concrete slab.

Except for the few changes noted under design, materials, and workmanship, Building 1178 still retains historic integrity in all aspects as a Test Track sled maintenance shop. Three original 4-light hollow metal exterior doors have been replaced with similar 1-light hollow metal doors. Original roll-up metal doors have been replaced in-kind. Nearly all of the architectural replacements retain the character of the original element or component. The paint chamber and metal enclosure at the southeast elevation are modular structures that are removable. The layout and design remains essentially unchanged. Although functions in some rooms have changed, Building 1178 continues to serve in support of the High Speed Test Track. Special management consideration is warranted. This facility may be eligible at a regional or a national level under Criteria A and/or C once the fifty-year construction date is met in the year 2004 due to its unique role as the High Speed Test Track sled maintenance shop. Recommend that future alterations take into account this building's distinctive function and design features. Recommend further research to determine historic association with Building 824 (Sled Maintenance Shop). This building appears to be well-maintained. No routine maintenance items noted.

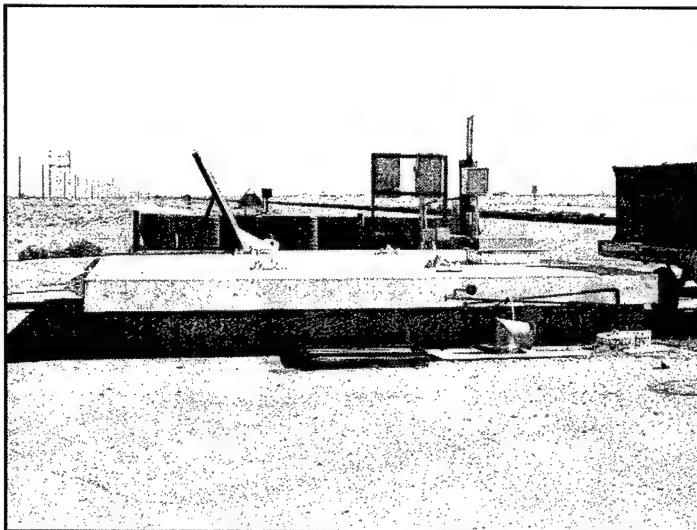
Current Condition: ☐ Intact ☒ Needs maintenance ☐ Deteriorated ☐ Archaeological

Building 1645 is a small (16' x 18') underground cable vault and missile instrumentation facility located between the High Speed Test Track and Building 1175. The concrete masonry unit walls and poured concrete floor are situated on a reinforced concrete foundation. Floor to ceiling height is approximately eight feet. The 16-gauge galvanized steel (flat) roof is situated at grade. Access to this facility is gained through a 2'-7" x 4'-0" roof hatch at the northwest corner.

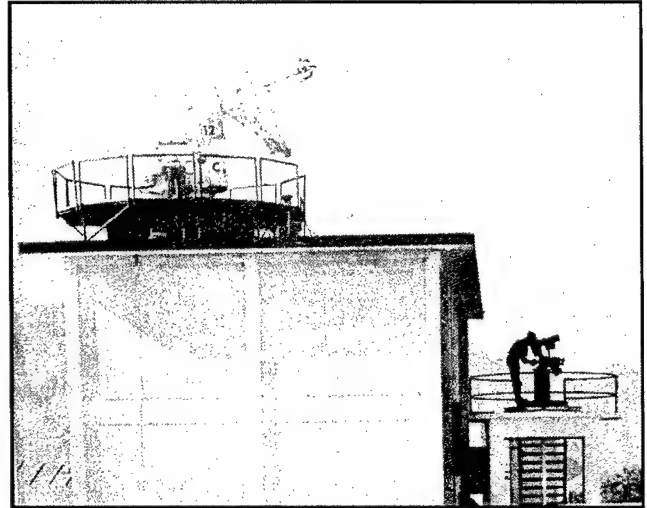
FPS-16 radar with an optical tracker.

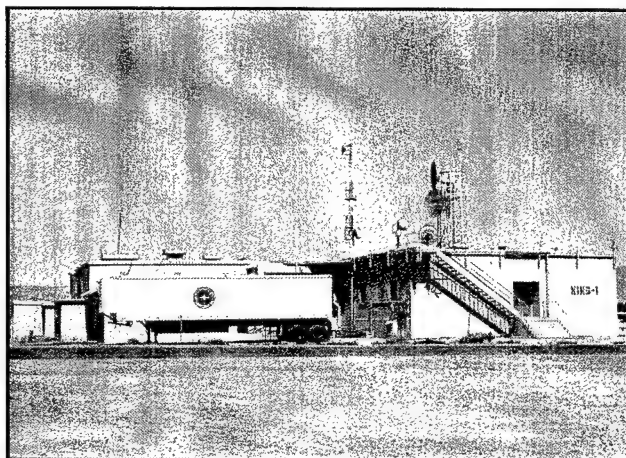
Current Condition: ☐ Intact ☒ Needs maintenance ☐ Deteriorated ☐ Archaeological

Foundation: Concrete footing and foundation wall. Column spread footing.

Suggested routine maintenance: Scrape, prime, and paint all block and concrete surfaces. Remove vegetation and rusted pipes by gas meter. Fill depressions at foundation, and regrade using gravel to promote positive drainage. Fill holes at concrete stoops. Replace wood bumper at dock using similar-sized lumber. Secure panel covers on abandoned electrical panels. Enclose live connections in junction boxes. Scrape, prime, and paint metal stairs. Reattach stair nose treads. Remove miscellaneous debris from building perimeter.

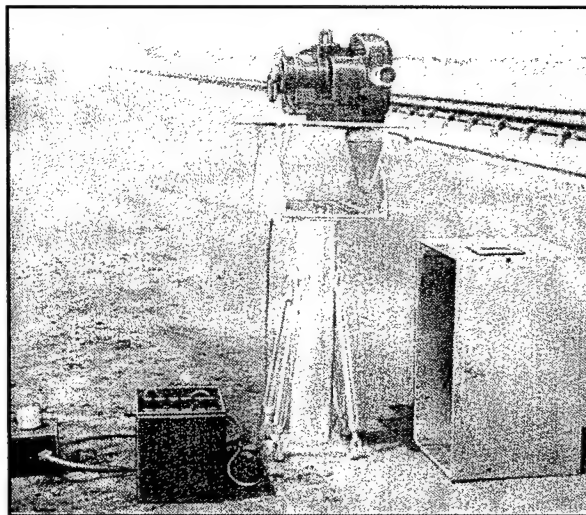
Land-Air Division film equipment at High Speed Test Track.

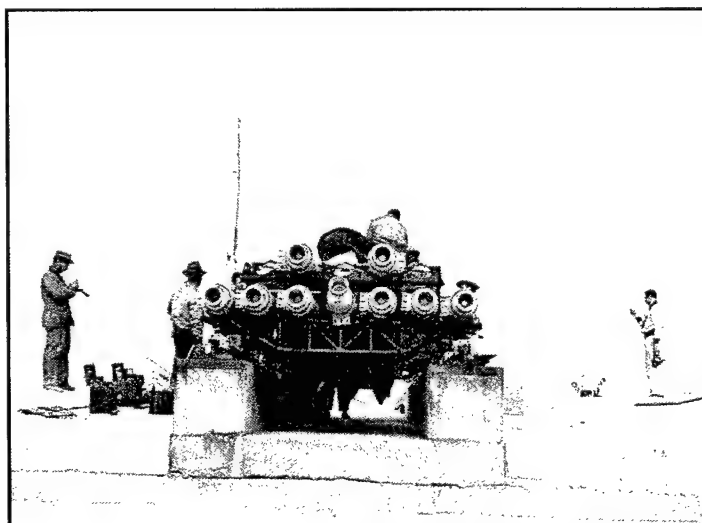
"While technicians work at strapping Lt. Col. John P. Stapp securely into the high speed test sled at Holloman Air Development Center, the nine rocket units are poised for firing. These units gave a total thrust of 40,000 pounds for five seconds which propelled the sled from a standing start to 632 miles per hour in 2800 feet. The subject underwent acceleration forces of 8 times gravity and in the deceleration phase withstood a force 35 times gravity."
